ROCK-SLOPE FAILURE IN PARTS OF THE SCOTTISH HIGHLANDS

GRAHAM HOLMES, B.Sc.

University of Edinburgh

1984

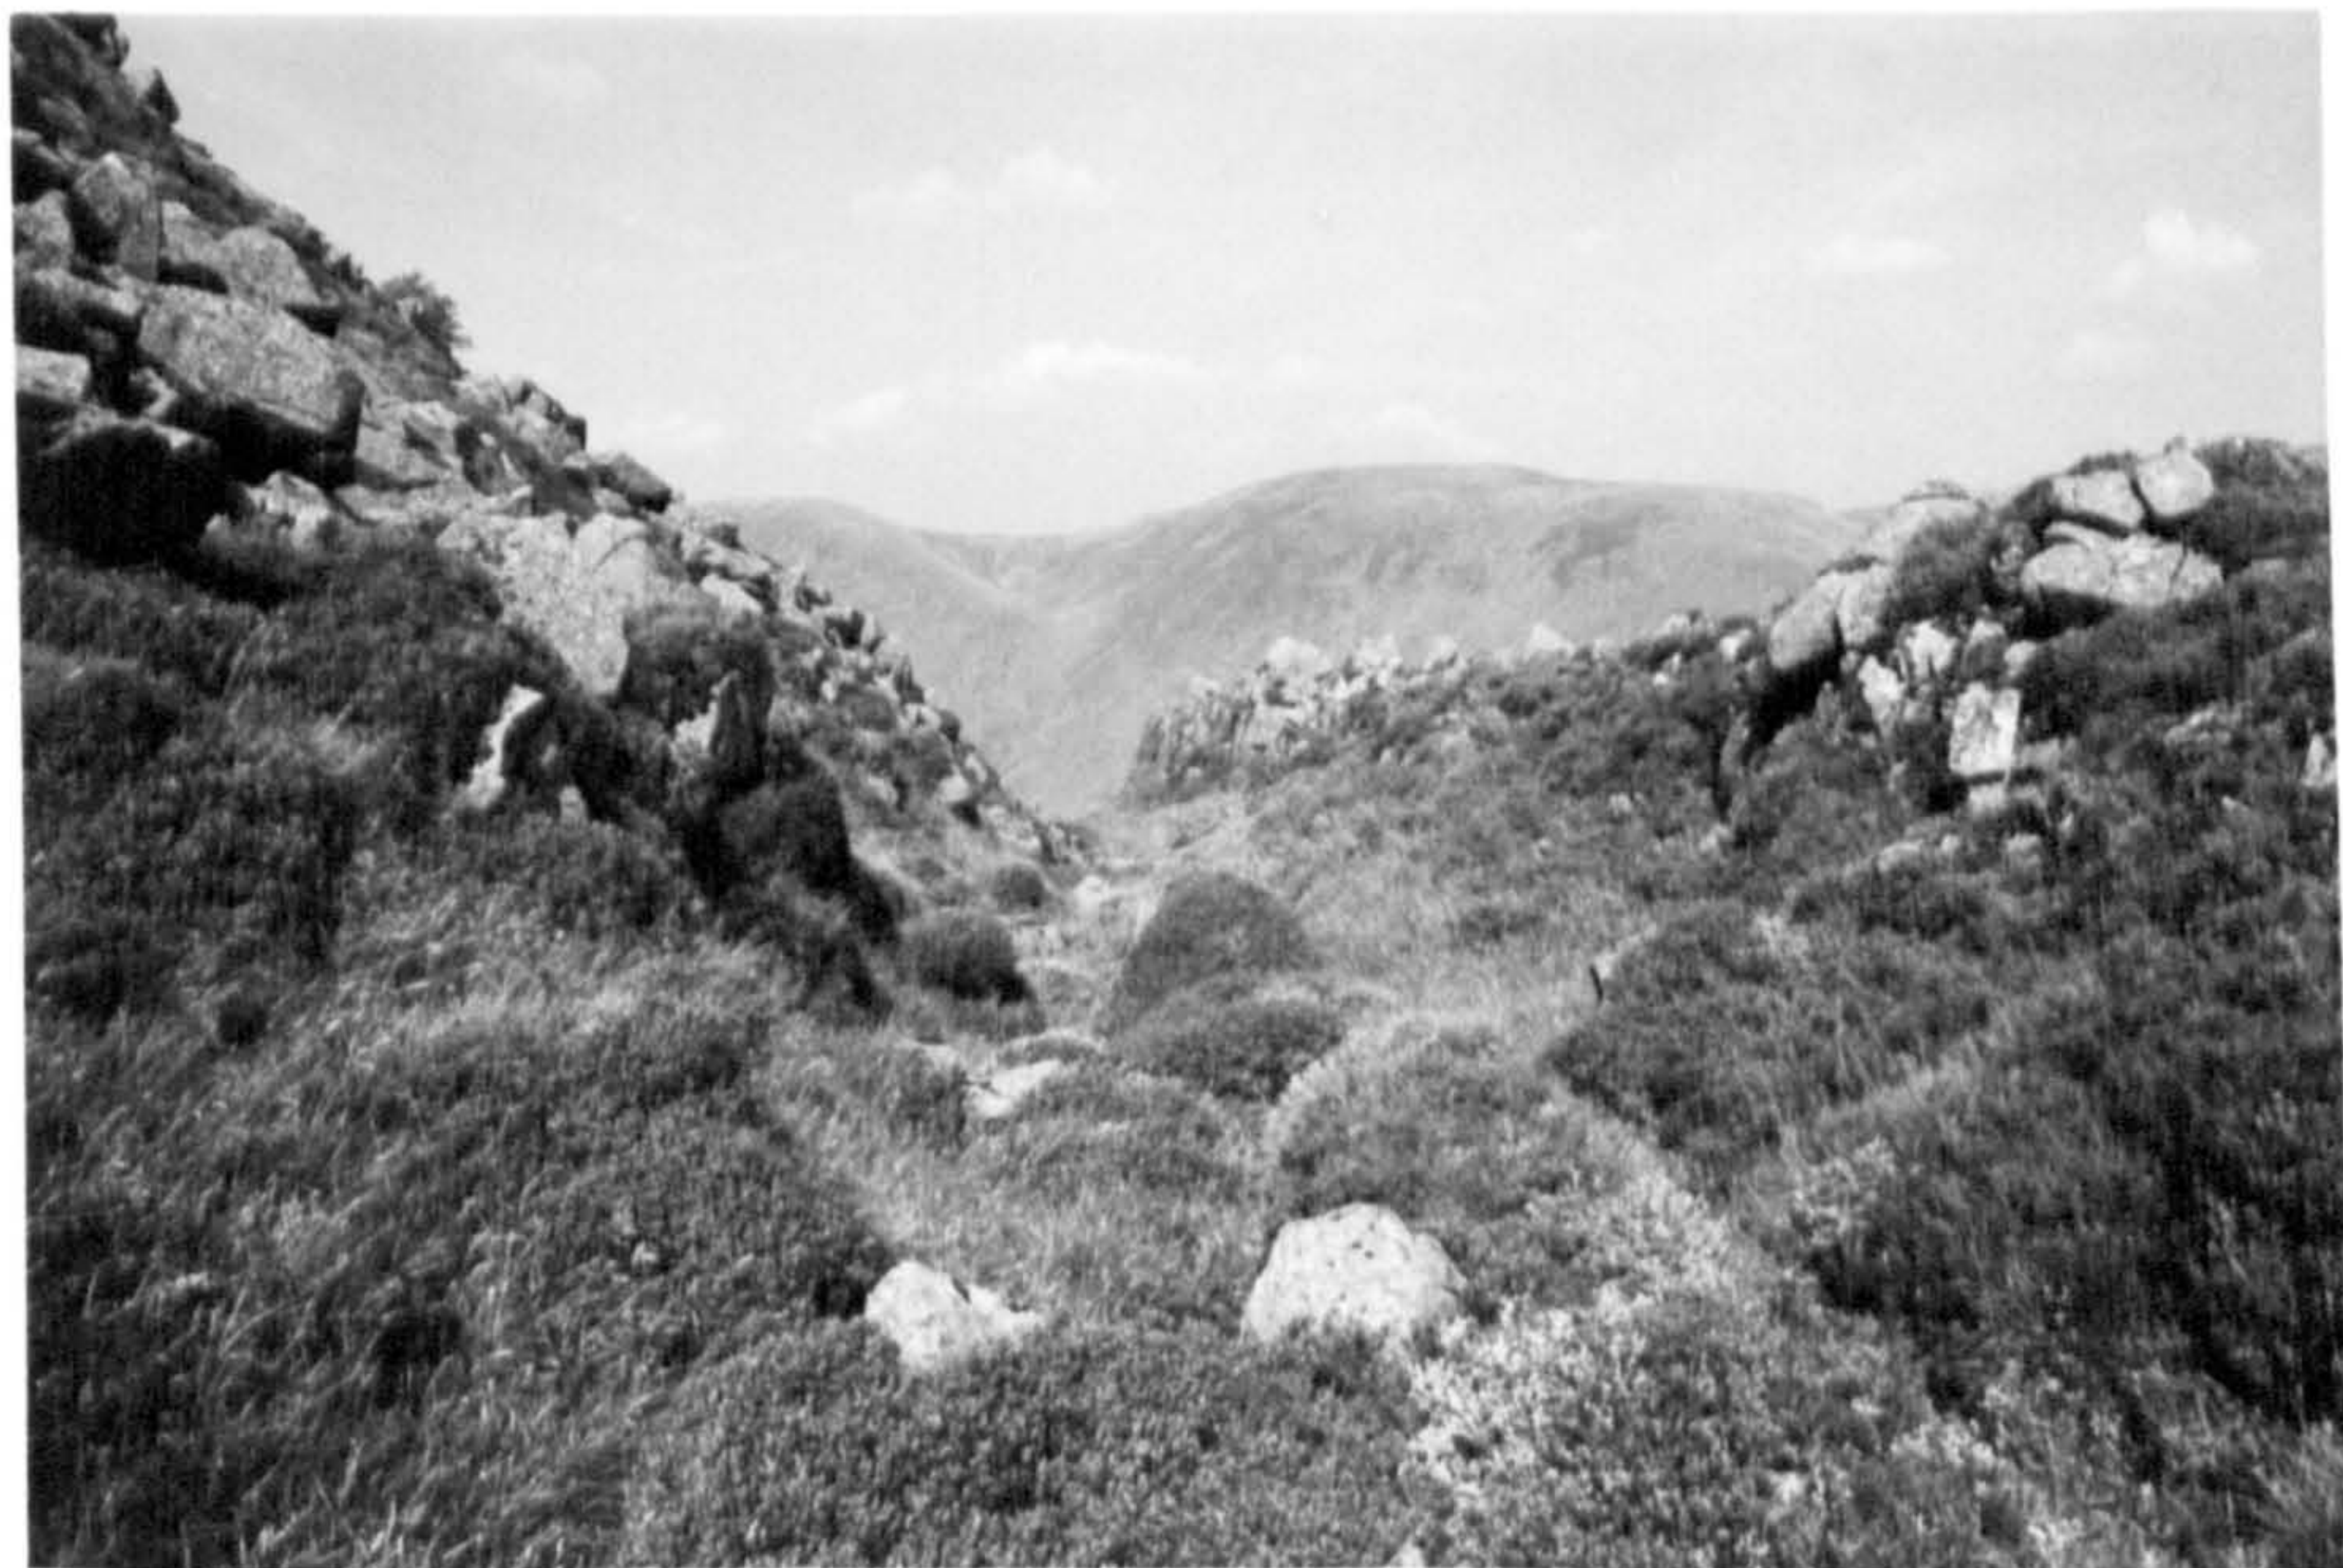
Plate 7.5: View N along the deepest obsequent-scarp at Cairn Broadlands (p 131). The trench is up to 2.5-m-deep.

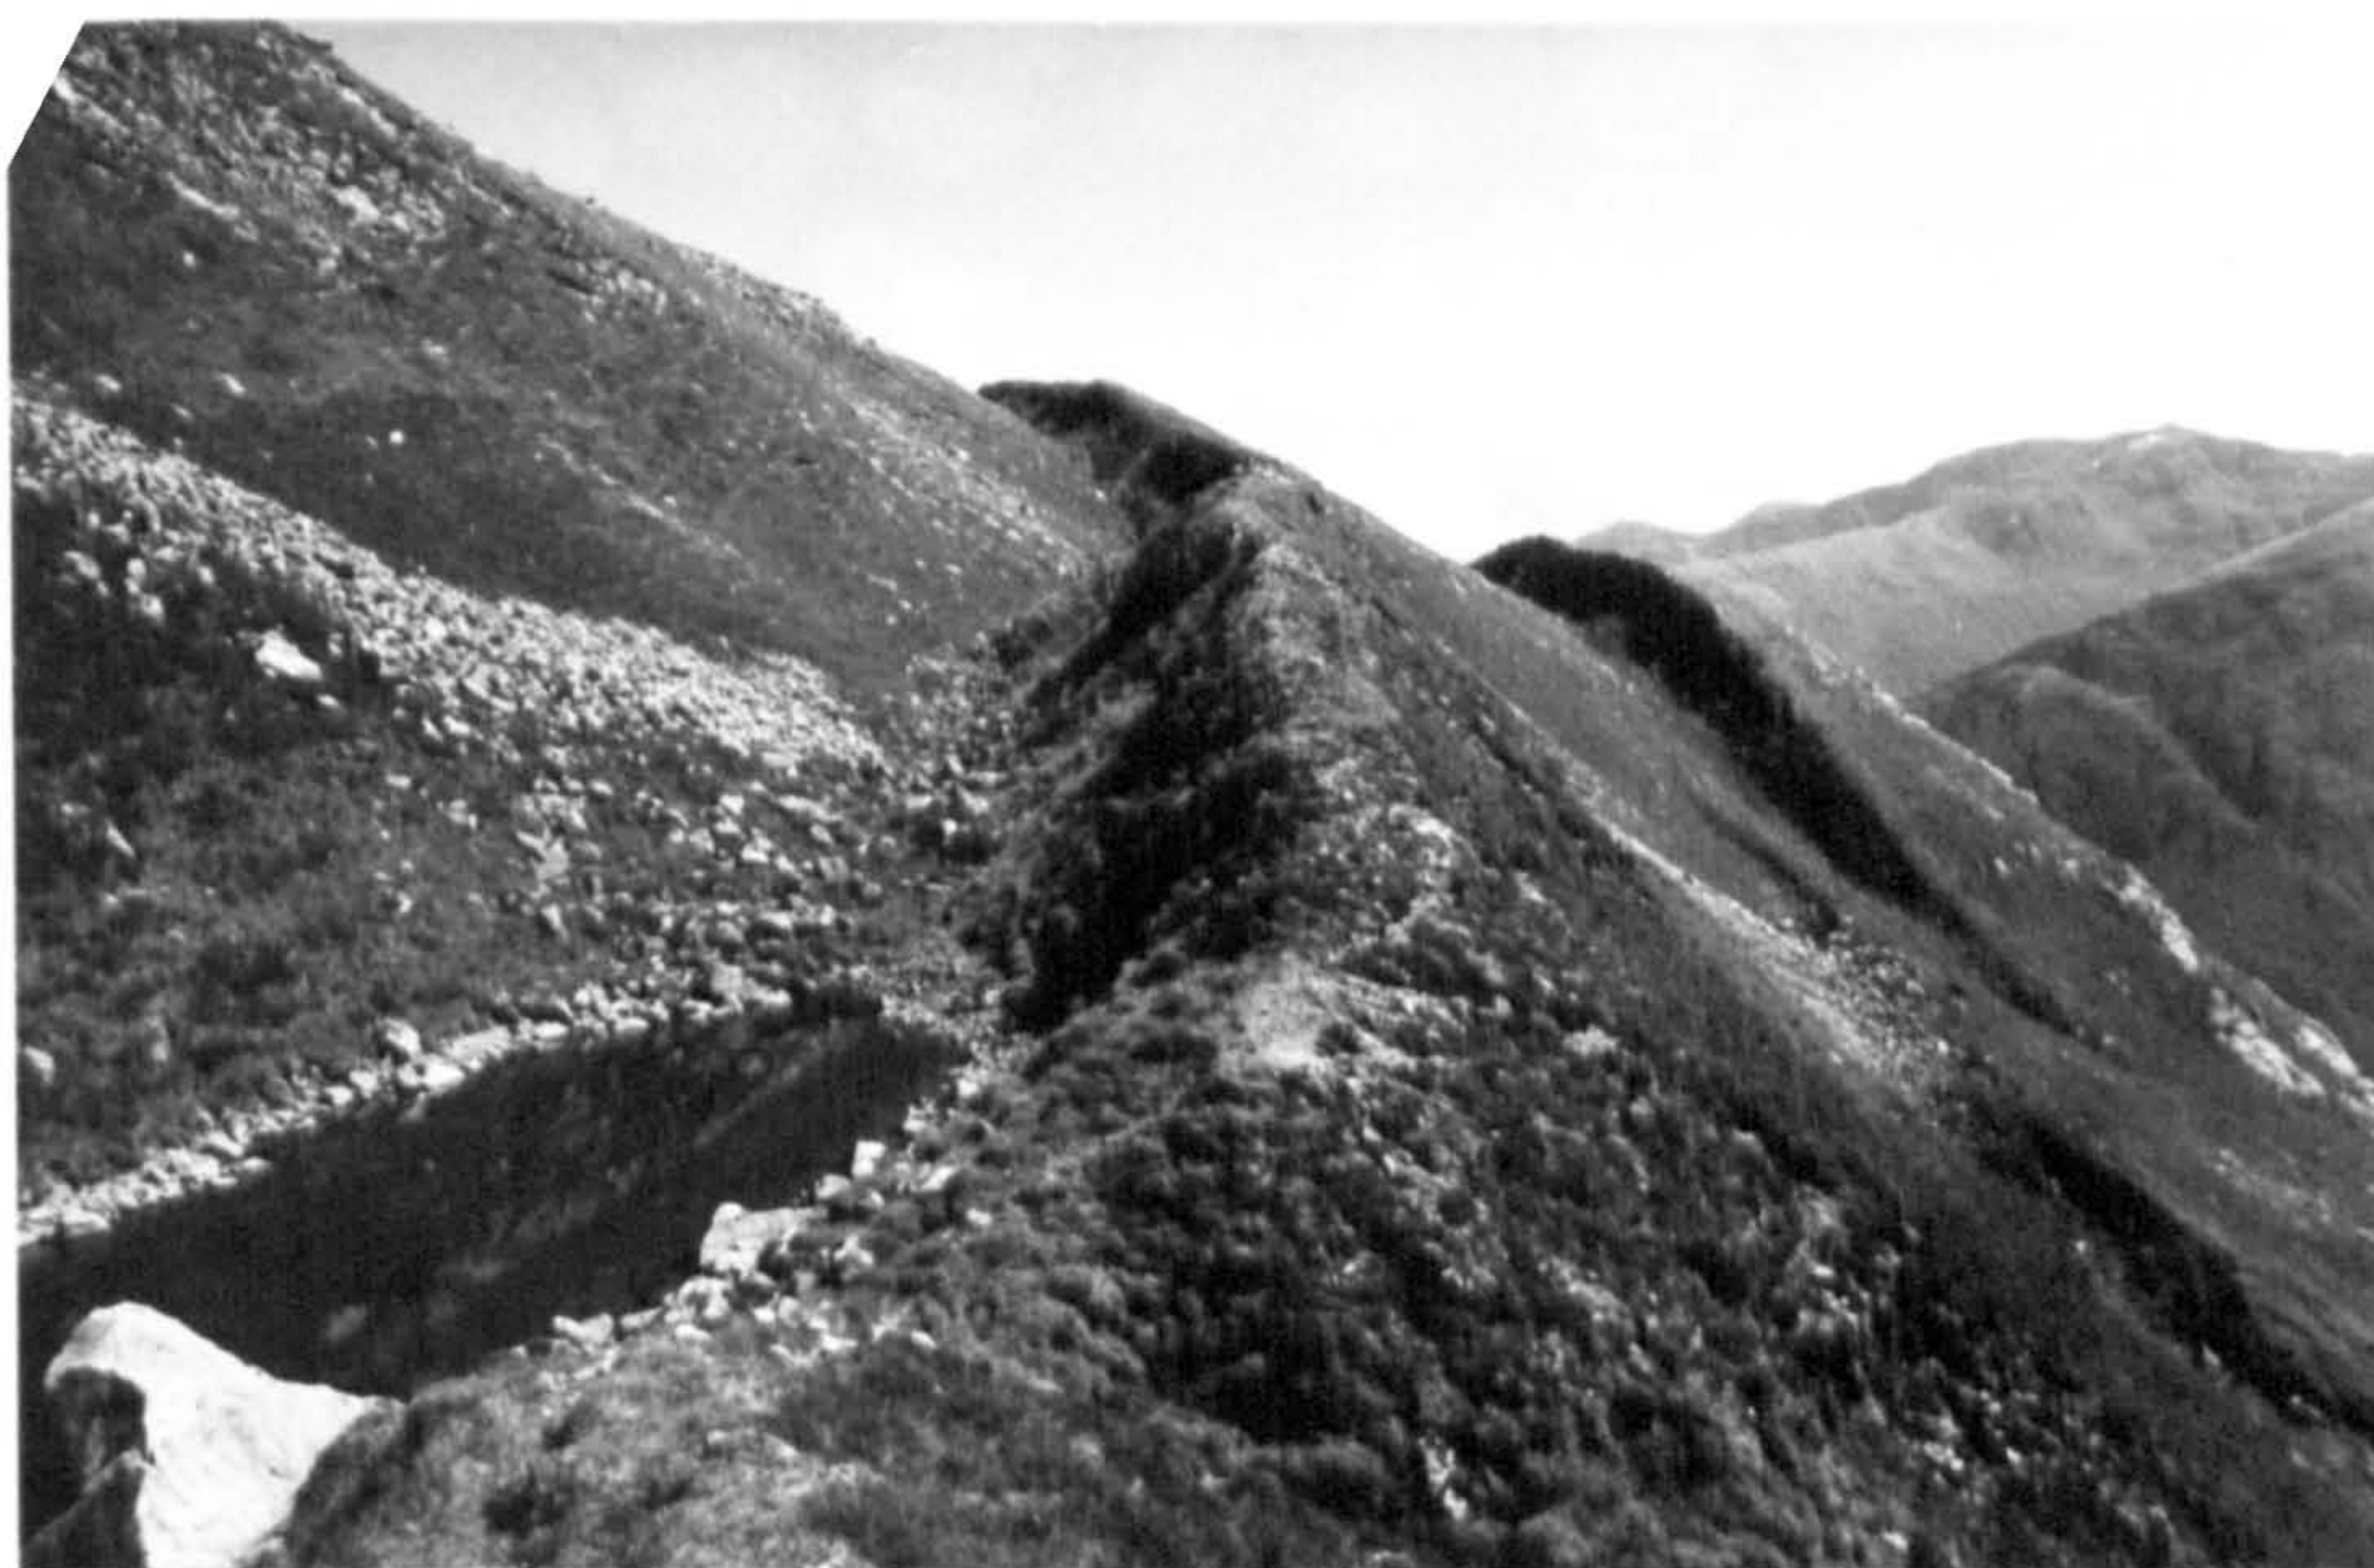
Plate 8.3: Obsequent-scarps on the Ben Attow slope. The examples shown here are up to 5-m-high. The location and direction of view is shown in Figure 8.5.

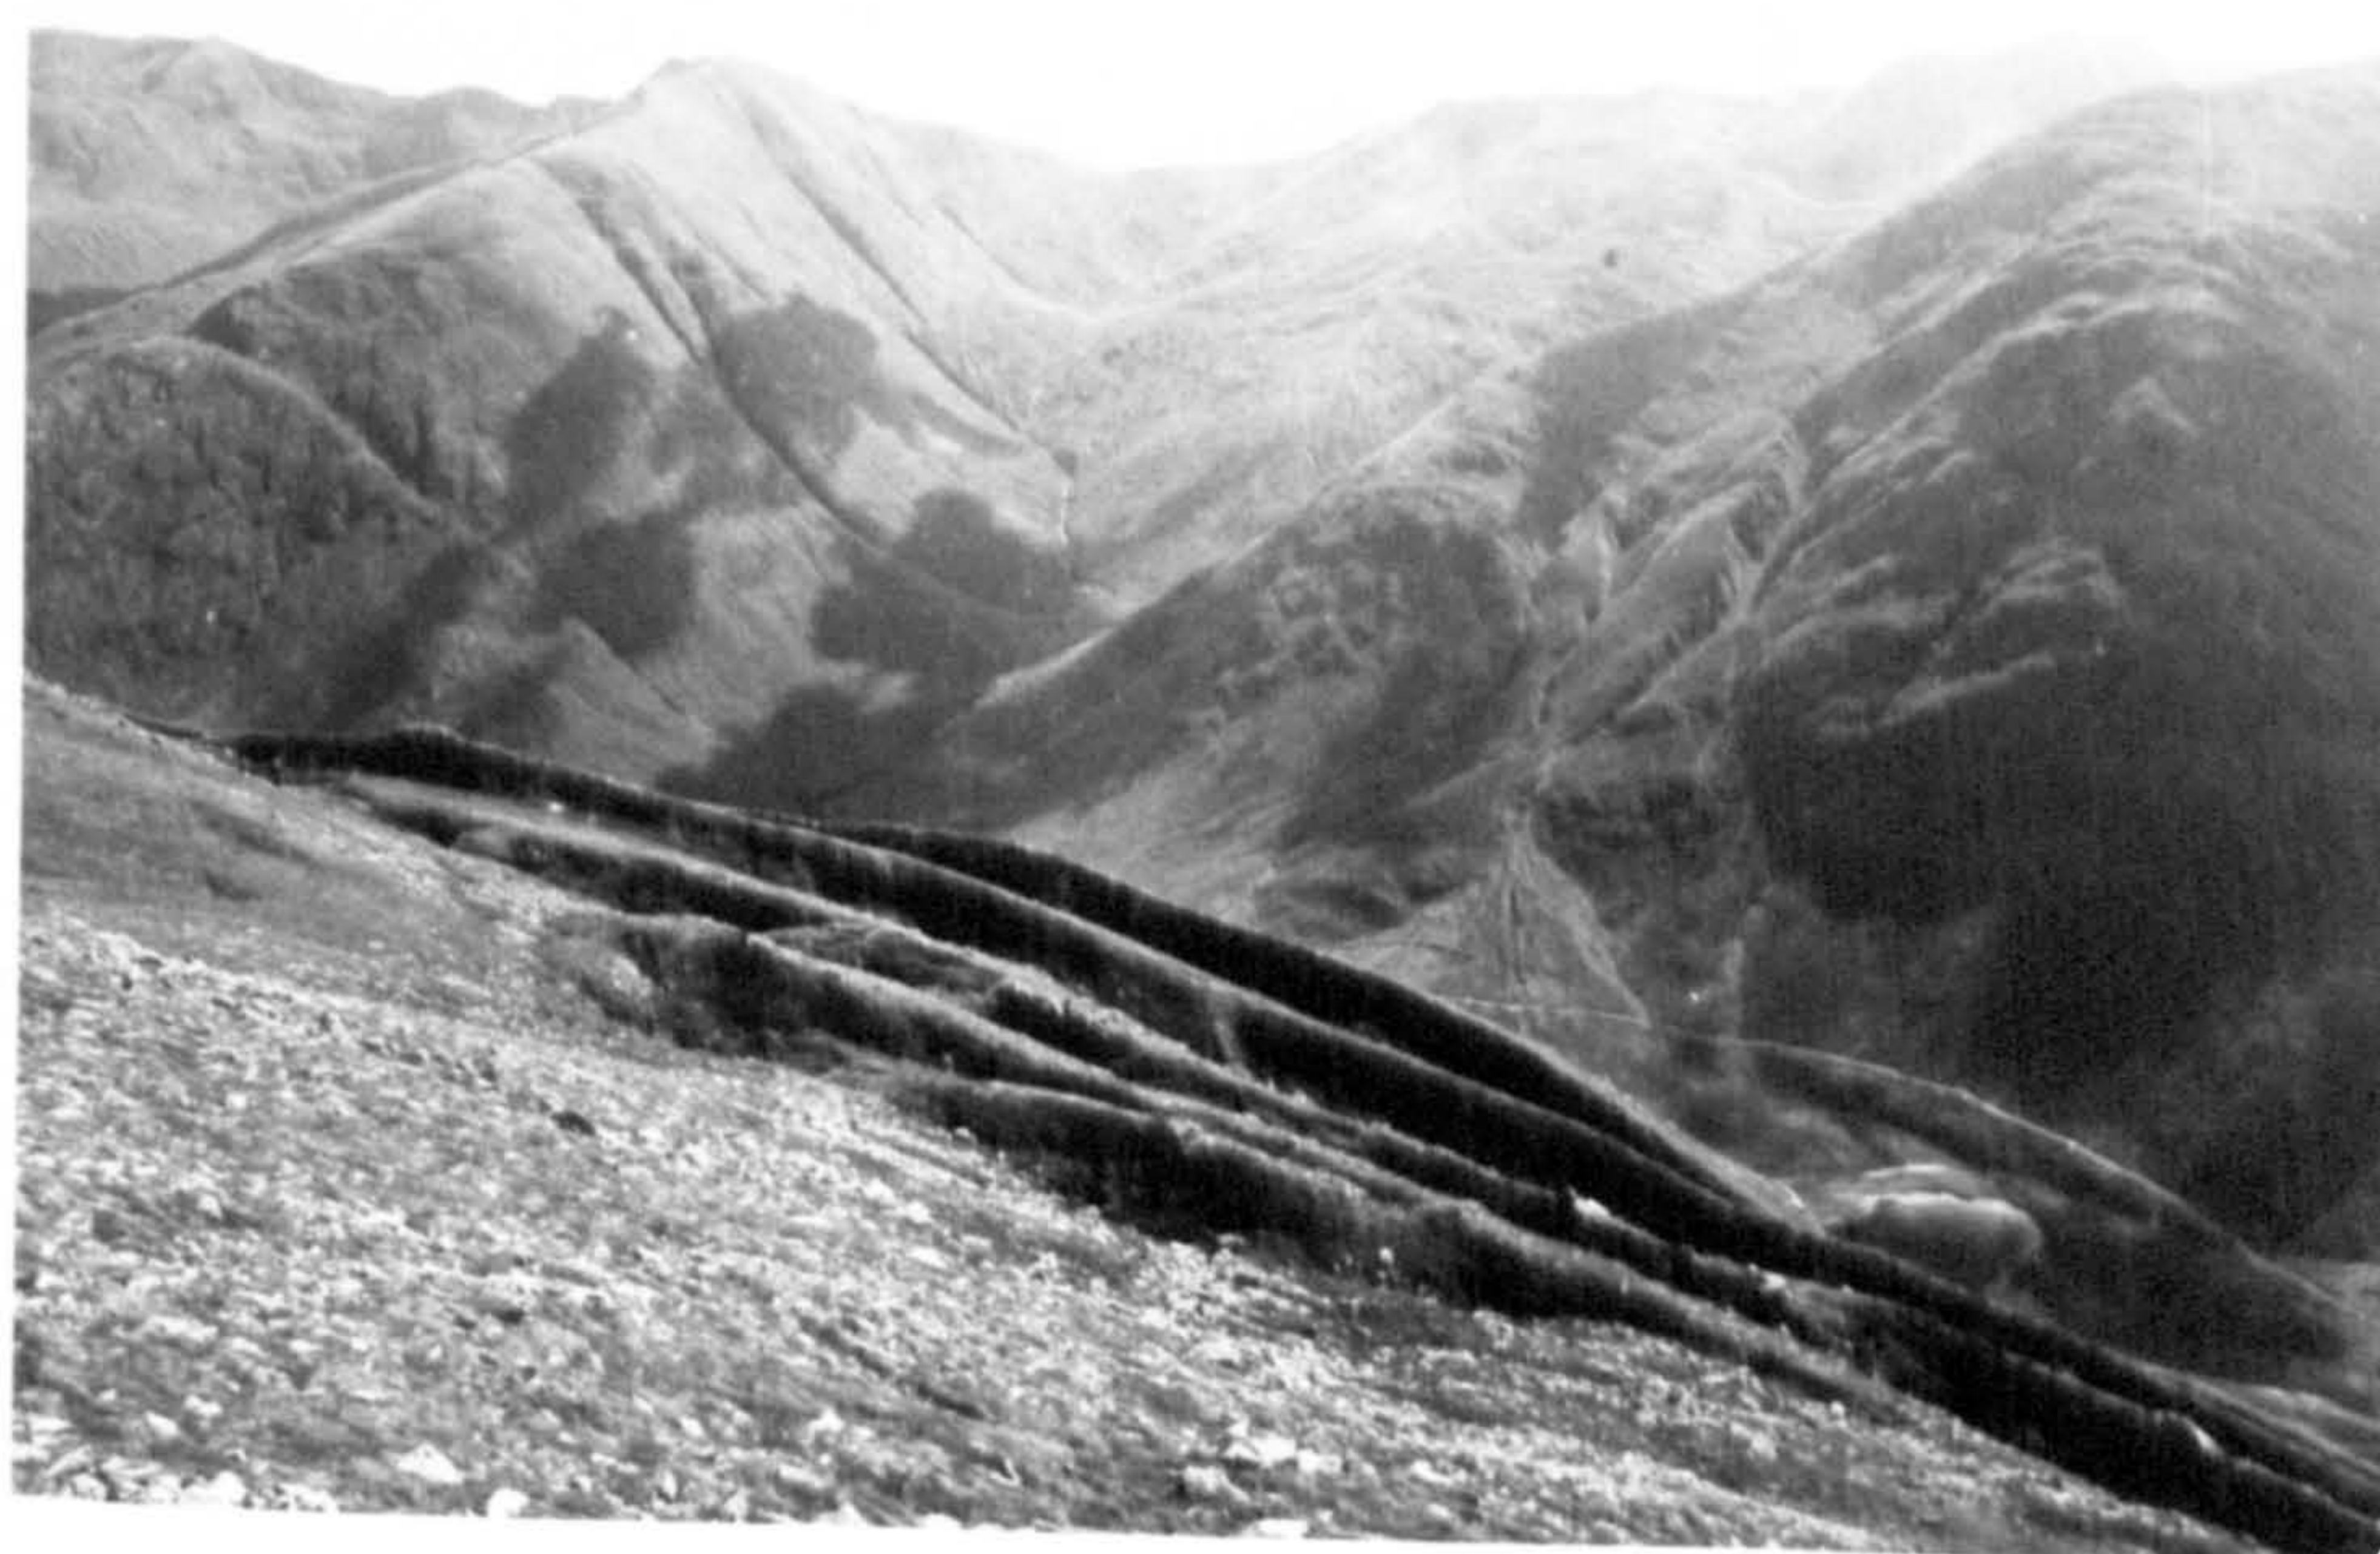
Plate 8.4: Closely-spaced obsequent-scarps on Ben Attow (at 1 in Figure 8.5). These examples range in height between 4 and 5 m.

the slope profile) has occurred with block-flexural toppling within the scale of the mass. This also provides the simplest explanation for the development of obsequent-scarps (1 in Fig. 8.5, Plate 8.4), which are up to 5-m-high and spaced at c. 30 to 40-m-intervals, as separation and sliding of blocks without toppling (cf. Watters 1972) would be unlikely in areas where the obsequent-scarps are closely-spaced.

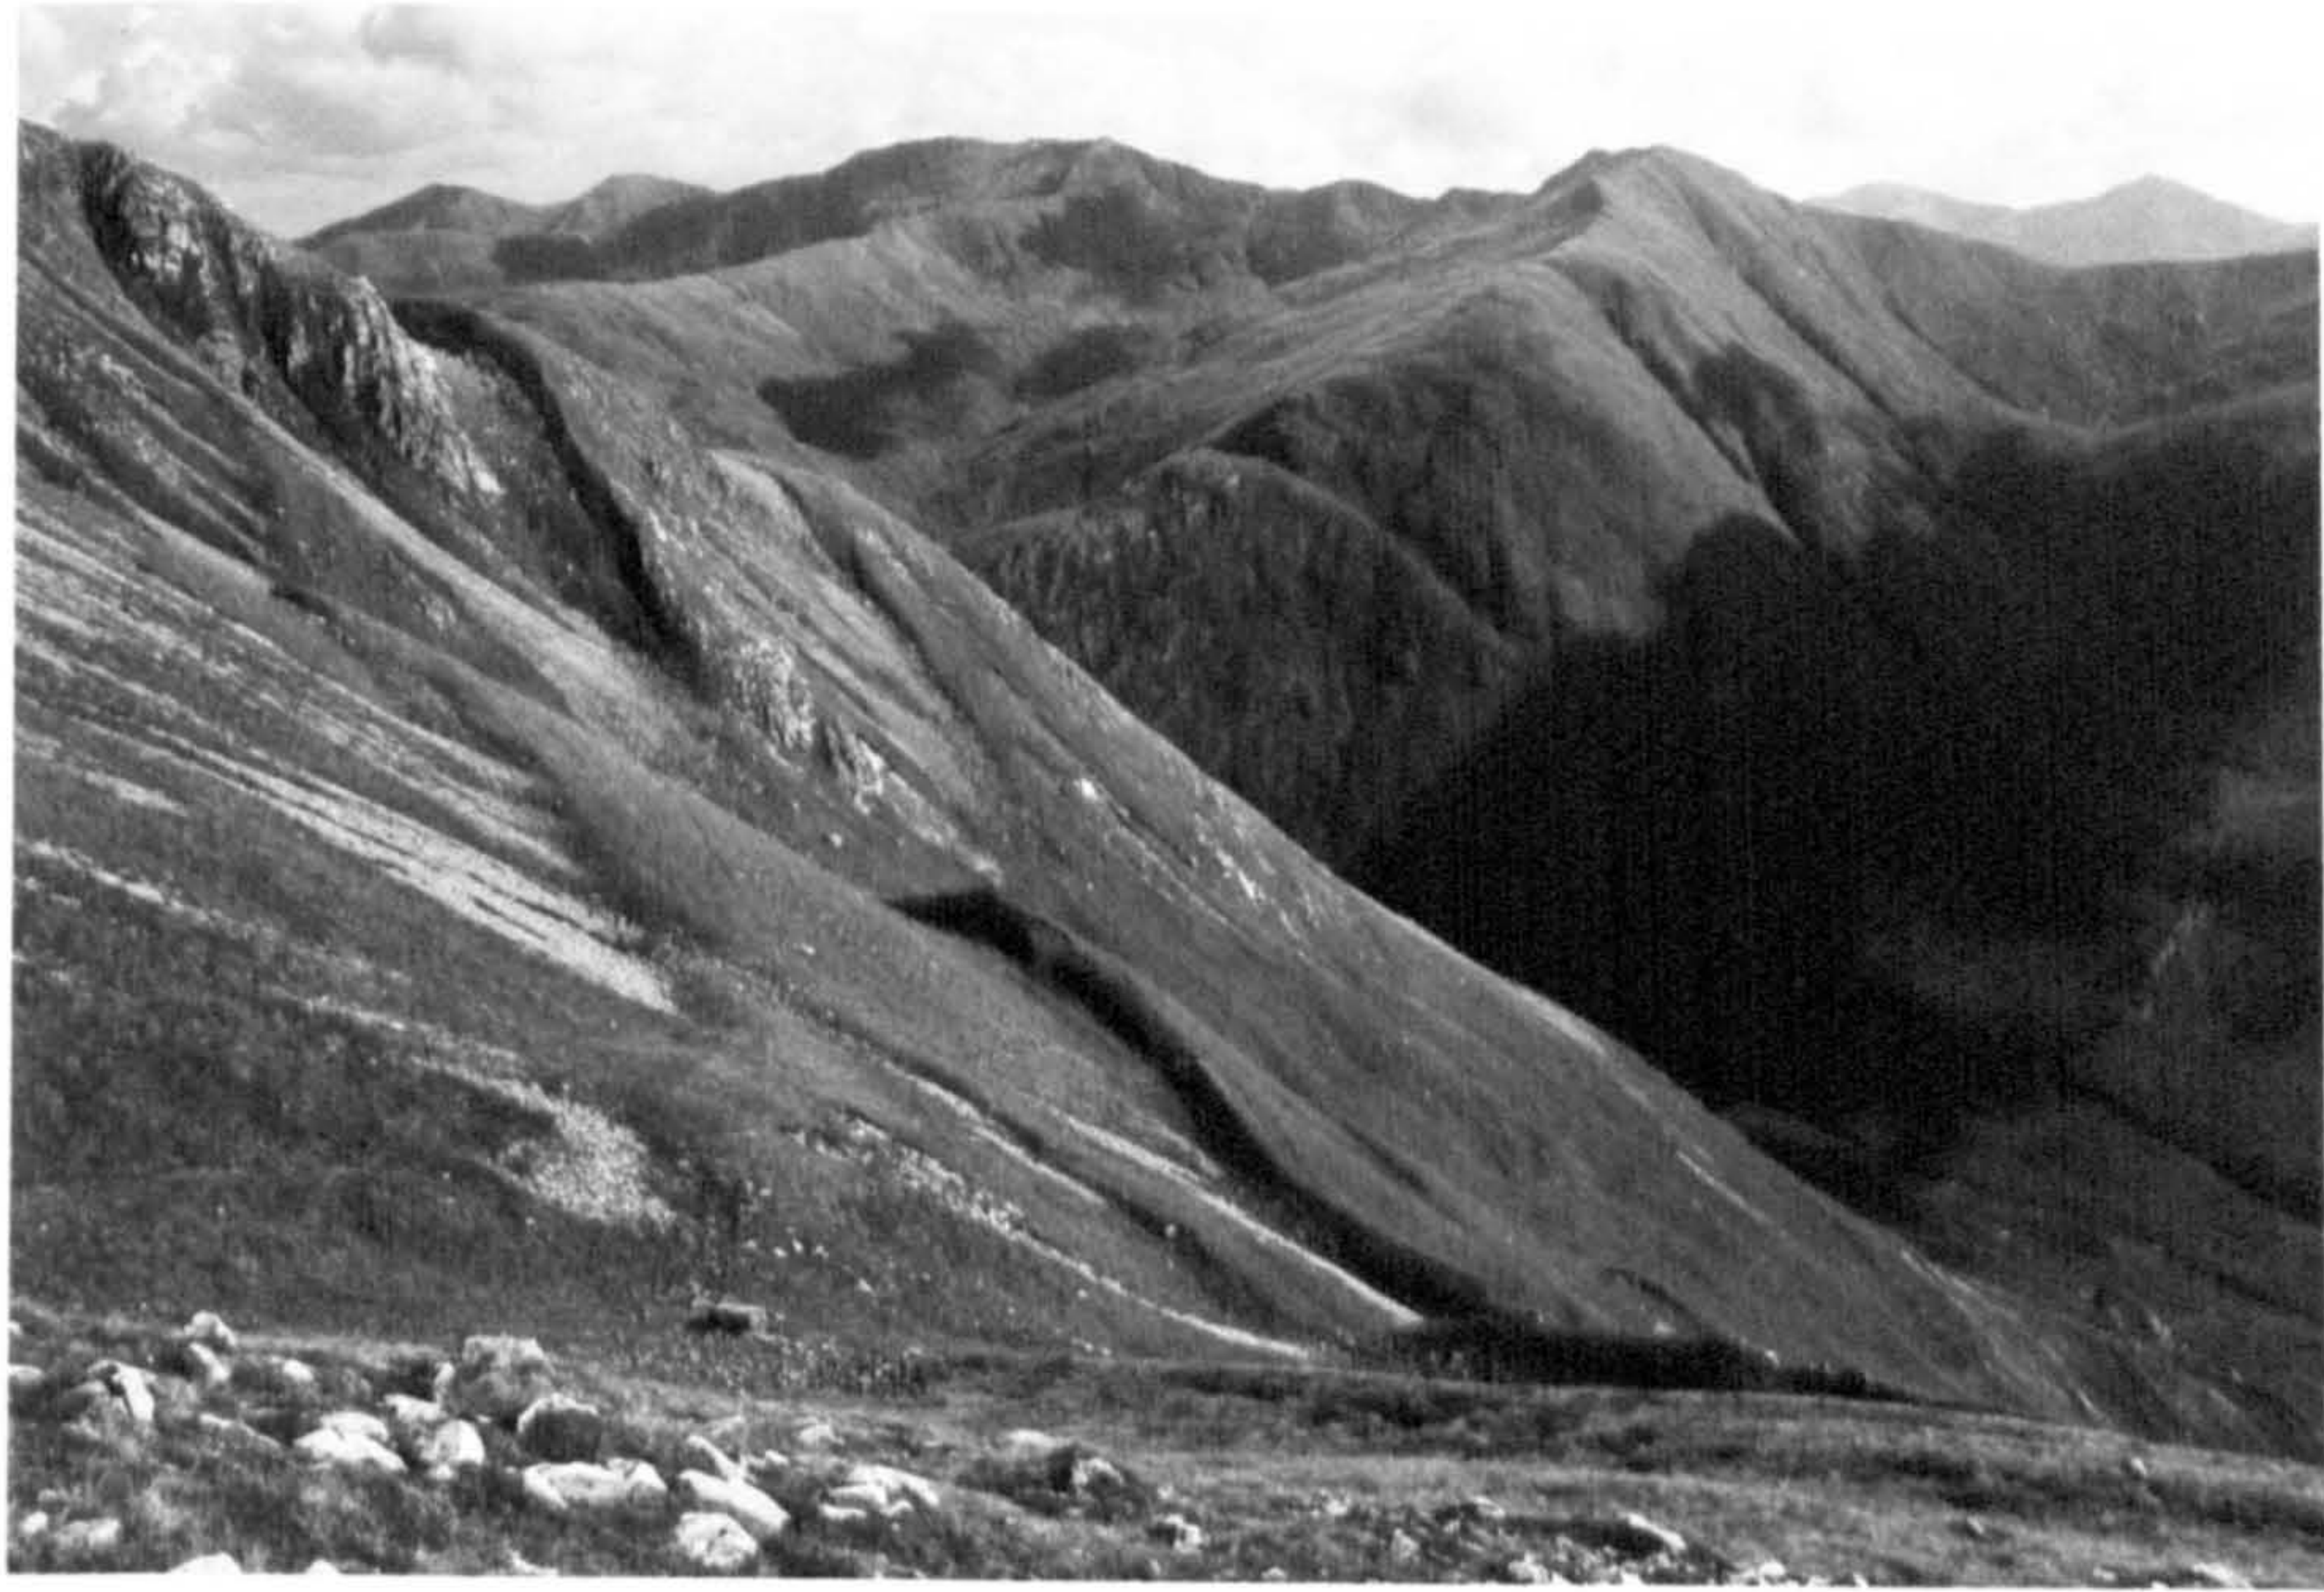
Plate 8.5: Obsequent-scarps on the Ben Attow slope. Note the accumulation of scree (the light areas) behind the obsequent-scarps.

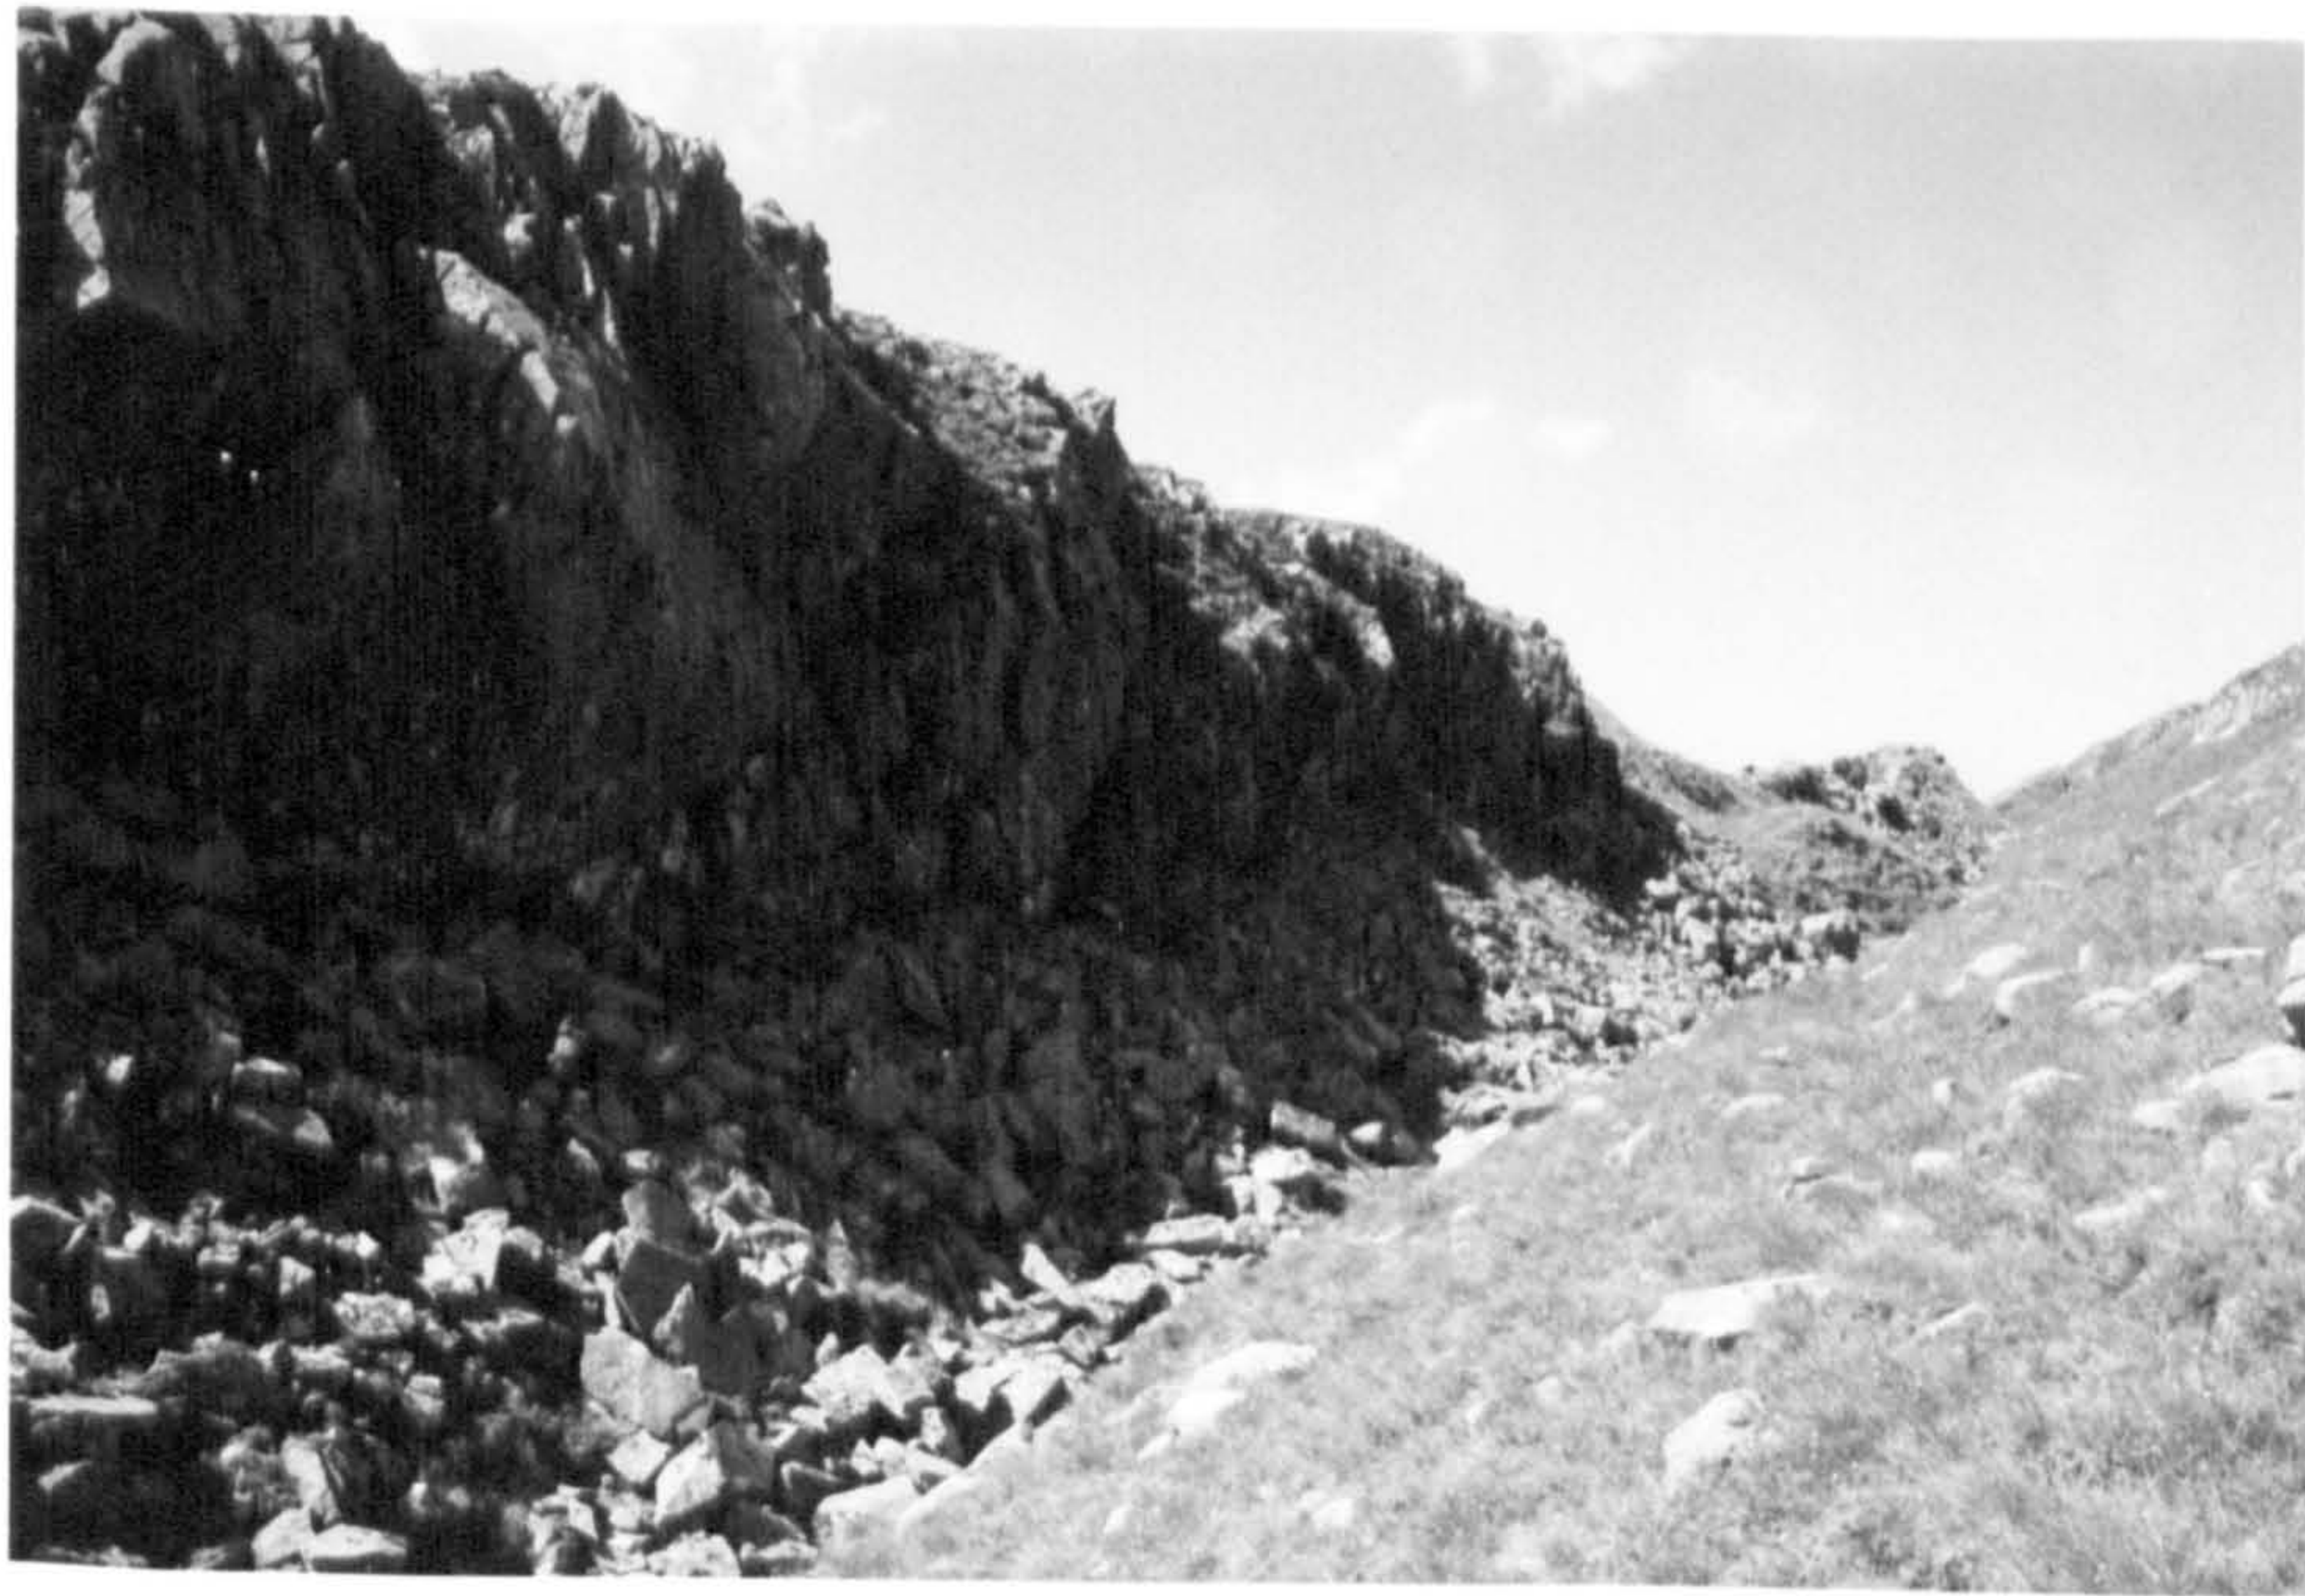
Plate 8.6: The largest obsequent-scarp on the Ben Attow slope. This example is up to 10-m-high. The blocks in the foreground have fallen from the uphill face of the scarp.

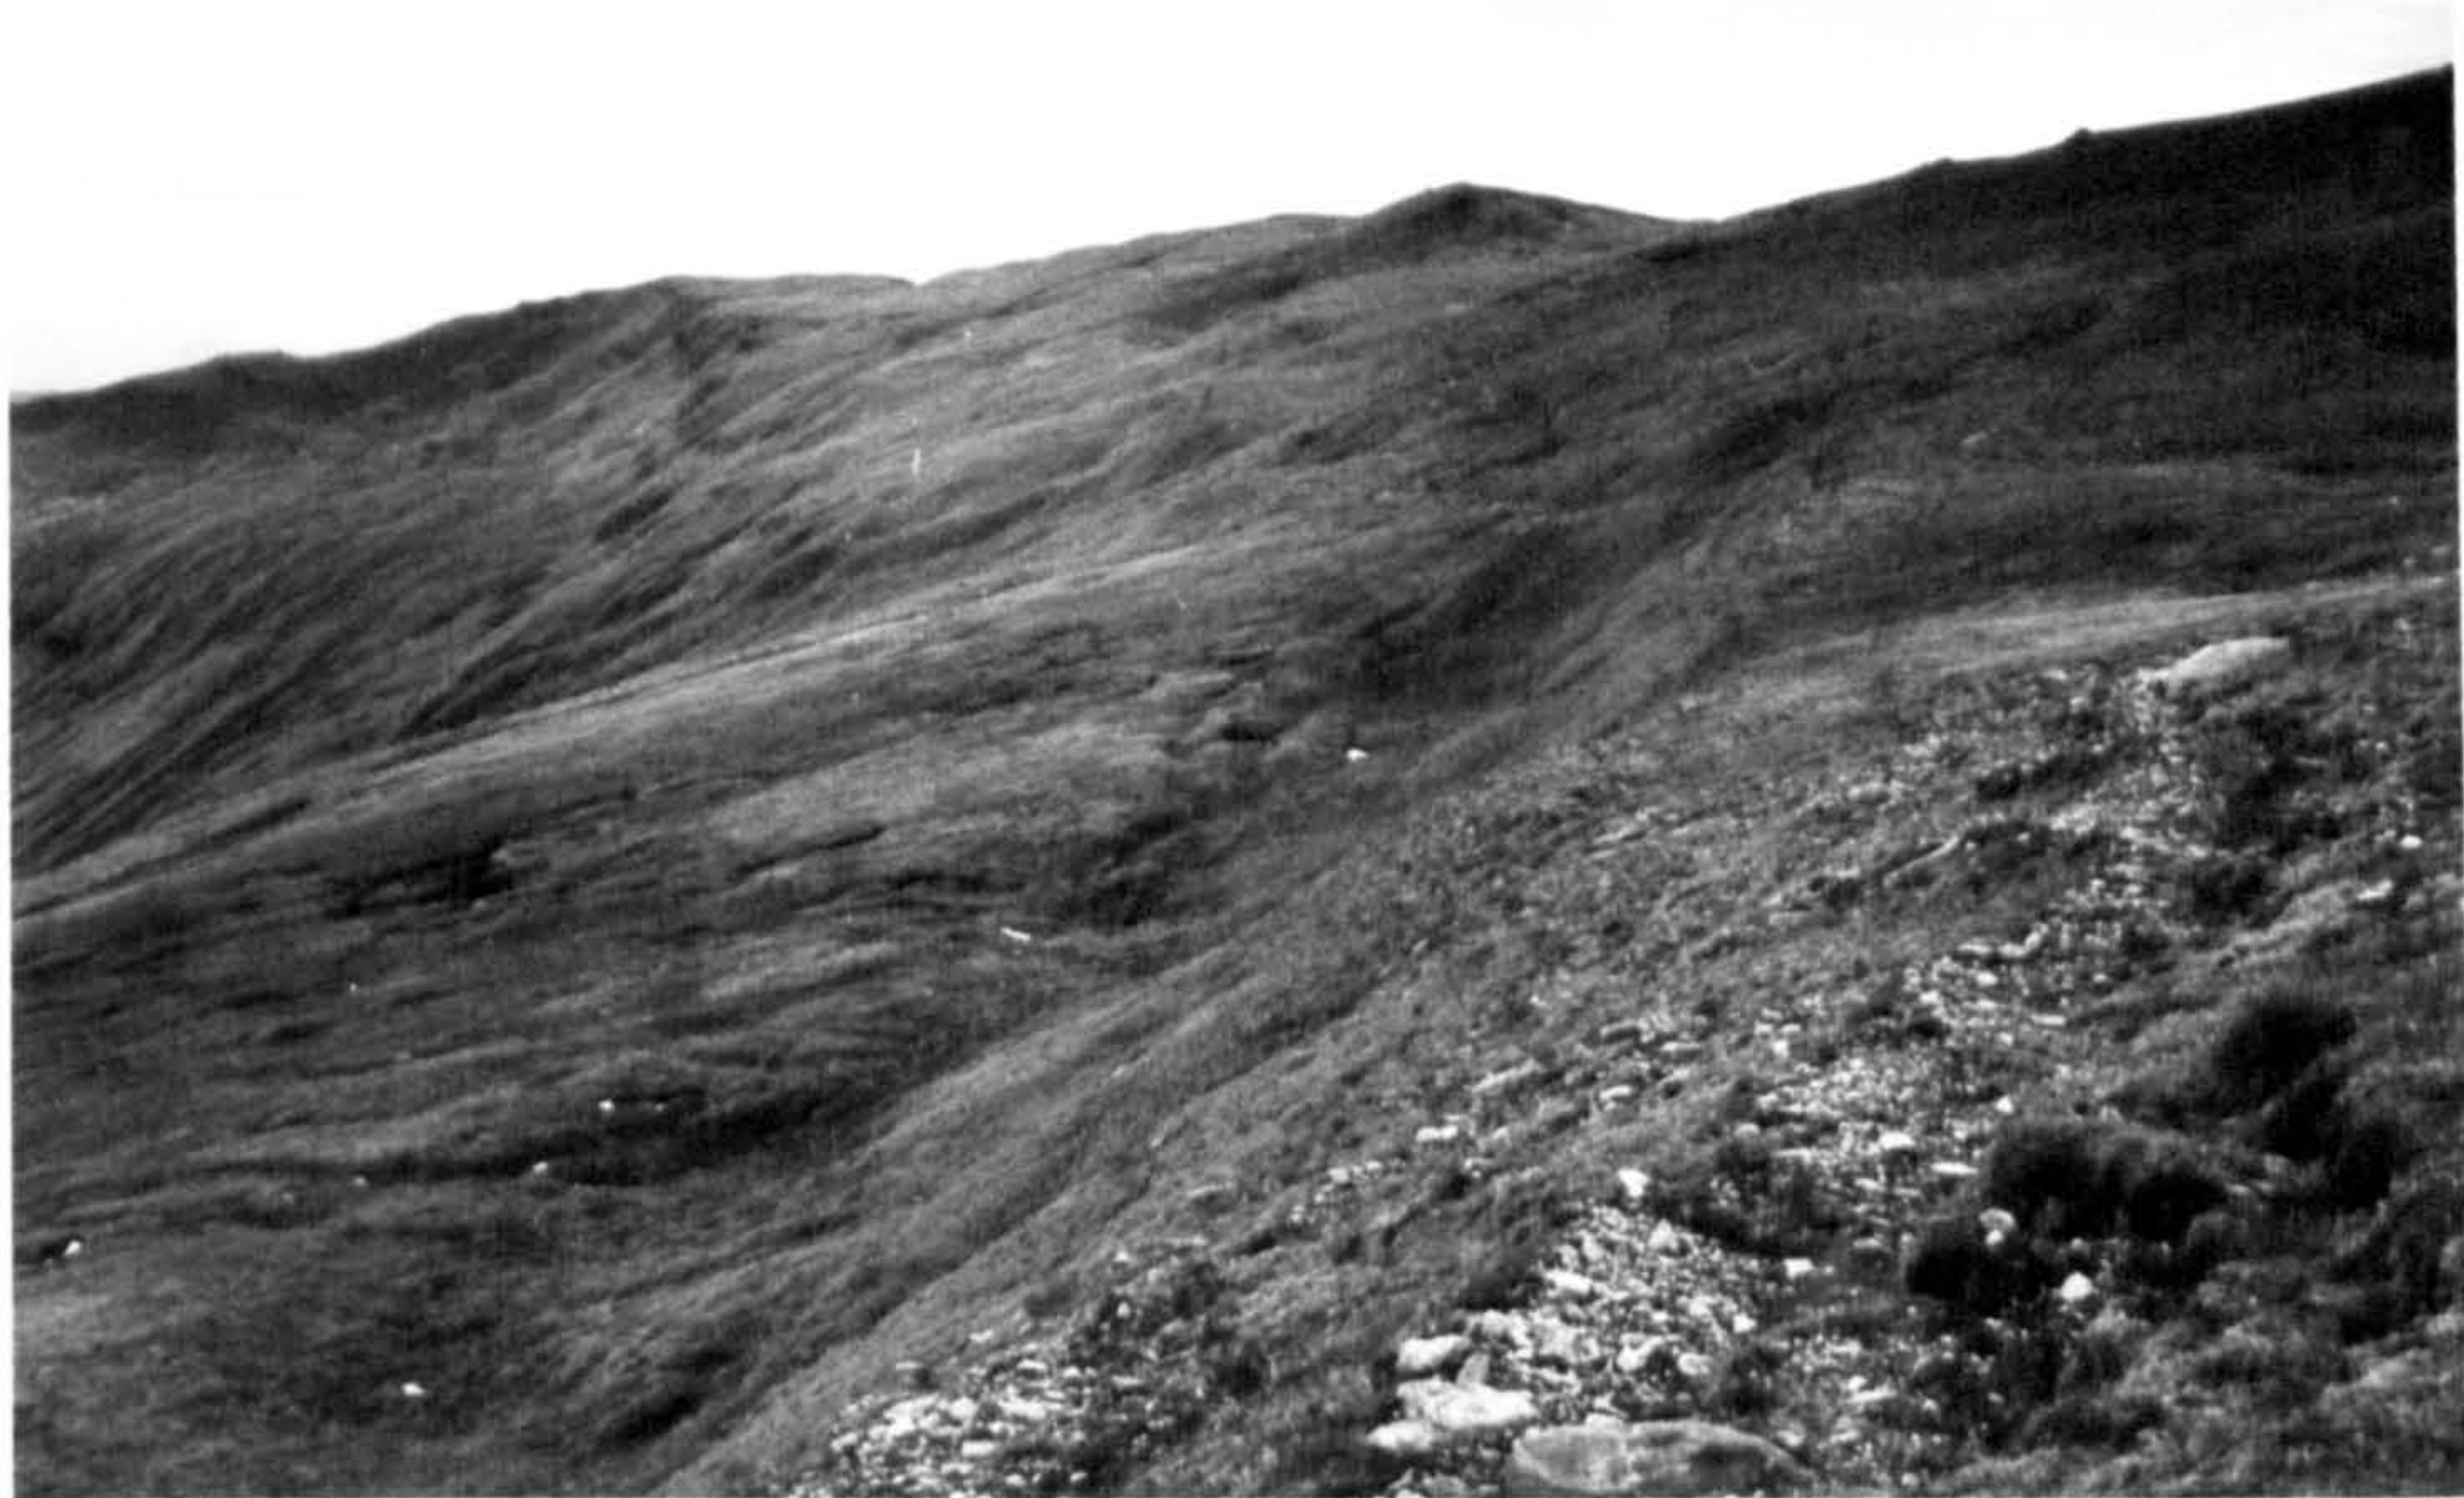
Plate 9.1: Periglacial debris overlapping the rear-scarp at Sgurr Breac in the Fannichs (A' Chailleach in distance).

- (i) periglacial landforms overlapping RSF features such as failure-scarps and obsequent-scarps (e.g. Plate 9.1);
- (ii) displacement/truncation of periglacial landforms (e.g. Plate 9.2);
- (iii) accumulation of periglacial debris behind RSF features (e.g. Plate 9.3).

In addition to the relict periglacial landforms, a range of active periglacial landforms have developed upon the rear-scarp at Sgurr Breac. The active forms include: various types of terraces, ploughing boulders and solifluction lobes (Plate 9.1). Active solifluction lobes have also formed on the S-facing rear-scarp on A' Chailleach.
